Navajo Abandoned Uranium Mine

Site Screen Report

Plot 13 AUM Site

August 2010

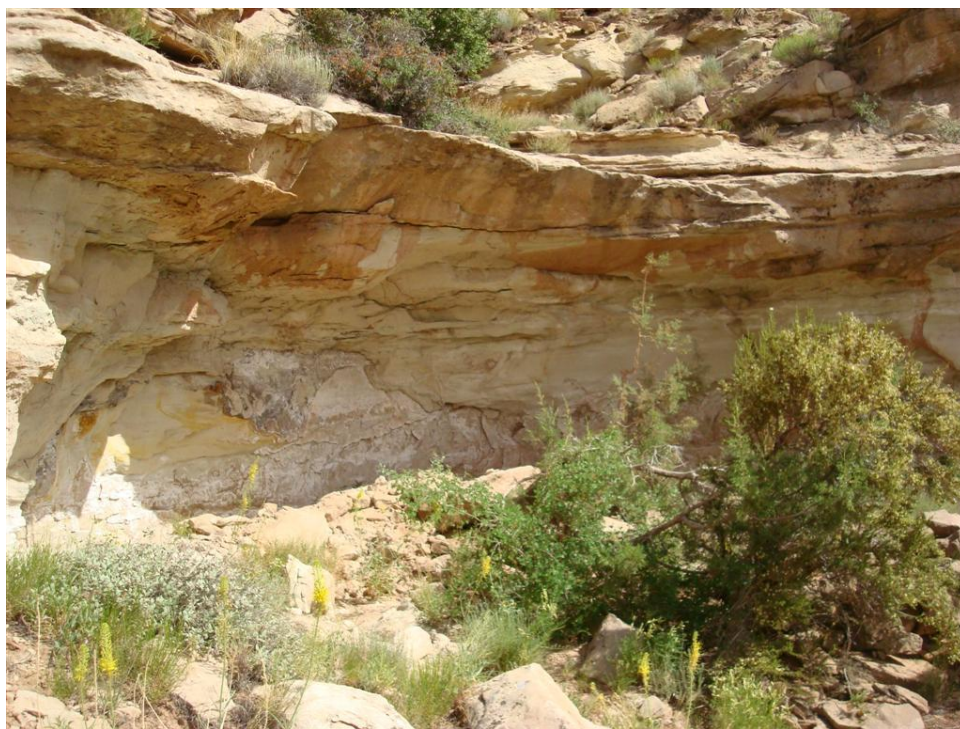
Photo 2. Plot 13 site, overhang

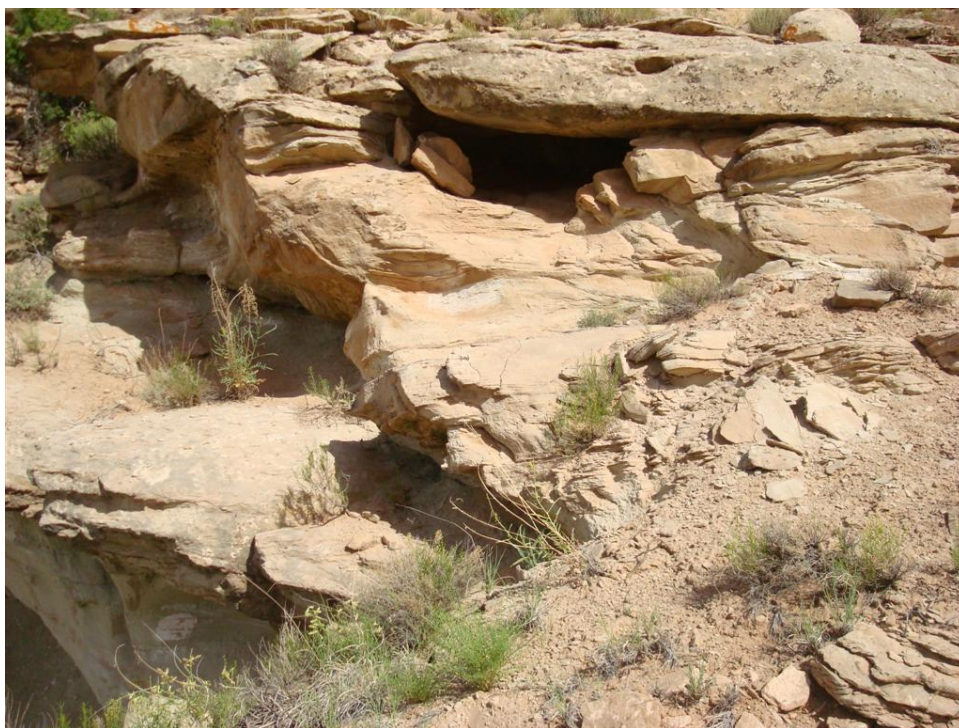
1 possible adit

Photo 3. Plot 13 site, possible adit

1possible adit; excavations of fine material below lowest restraint ledge
